## **APPENDIX E: TERRESTRIAL BIODIVERSITY SPECIALIST STUDY**

# Proposed Upgrade of Bayhead and Langeberg Roads in the Port of Durban, eThekweni Municipality, KwaZulu-Natal

## TERRESTRIAL BIODIVERSITY COMPLIANCE STATEMENT

08 July 2026

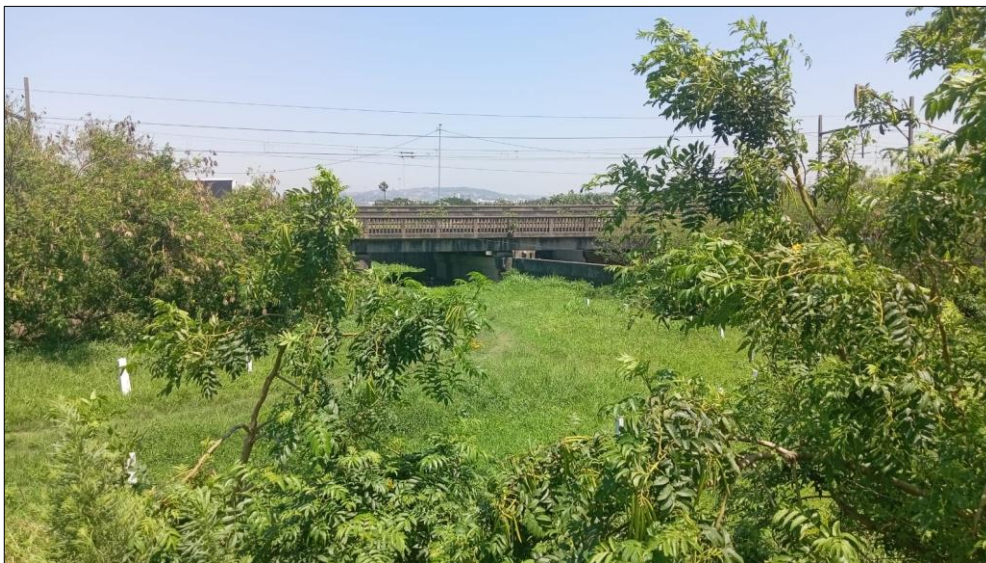
**Figure 19. Photo 02:** *Tecom stans* invasion visible in the foreground and background (Community 1) with mowed lawn in between (Community 2) along Bayhead Road.

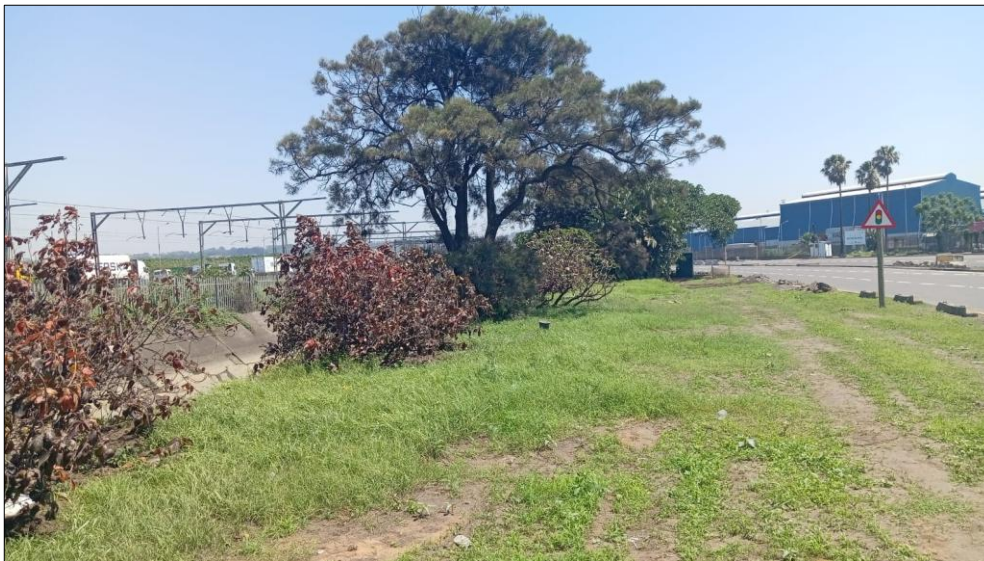
**Figure 20. Photo 03:** Example of a mowed road verge with *Casuarina equisetifolia* and other planted trees and shrubs visible in the foreground and background along Bayhead Road.

These areas primarily comprised shortly cropped grass cover with a mixture of ruderal grasses including *Sporobolus africanus*, *Digitaria eriantha*, *Sporobolus pyramidalis*, *Panicum maximum*, *Digitaria eriantha*, *Imperata cylindrica* (in localised patches along Langeberg Road) and *Cynodon dactylon* with low scattered cover of *Senecio madagascariensis* as well as *Plantago lanceolata*, *Heliotropium amplexicaule*, *Conyza sp*, *Tagetes minuta* and *Bidens pilosa* in some areas. Scattered clumps of trees which include a mixture of indigenous and planted exotic trees and shrubs are interspersed between more open areas of shortly cropped grass. Vegetation within these tree clumps include various indigenous *Ficus* species, *Brachylaena discolor*, *Strelitzia nicolai*, *Phoenix reclinata*, *Erythrina lysistemon* and *Vachellia xanthophloea* and exotic species including *Casuarina equisetifolia*, *Plumeria sp*, and *Acalypha wilkesiana* with *Ipomoea purpurea* growing over this exotic hedge. More shaded areas underneath mature trees were dominated by *Asystasia gangetica*. Low scattered cover of alien shrubs such as *Ricinus communis*, *Solanum mauritianum* and *Chromolaena odorata* were also noted in some areas. It was noted during the rapid site visit that cement barriers had been installed along the proposed alignment already (See Photo 4) and that construction rubble had been piled along the road verge in one instance (see Photo 7).

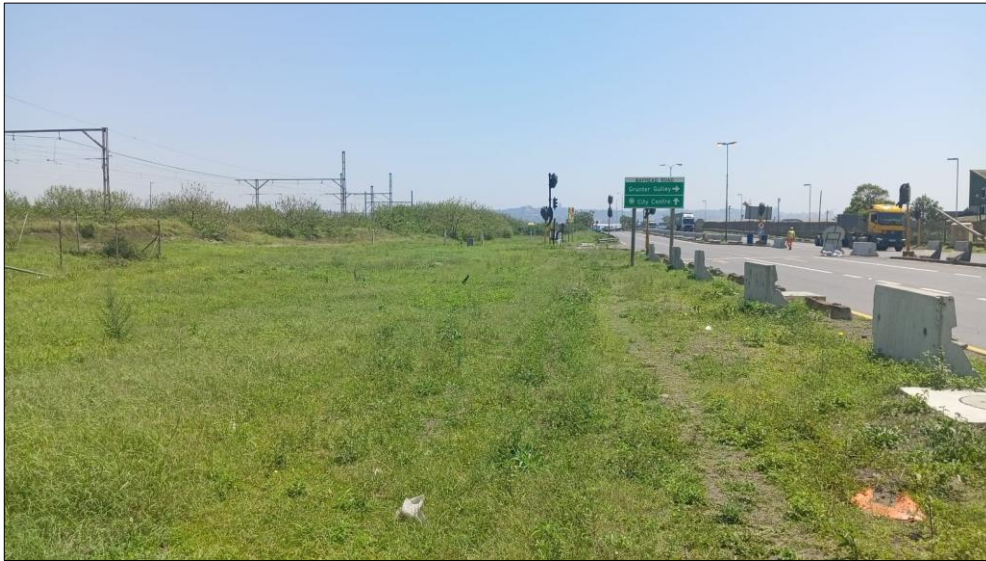
**Figure 21. Photo 04:** Mowed lawn with scattered ruderal weed cover along Bayhead Road.

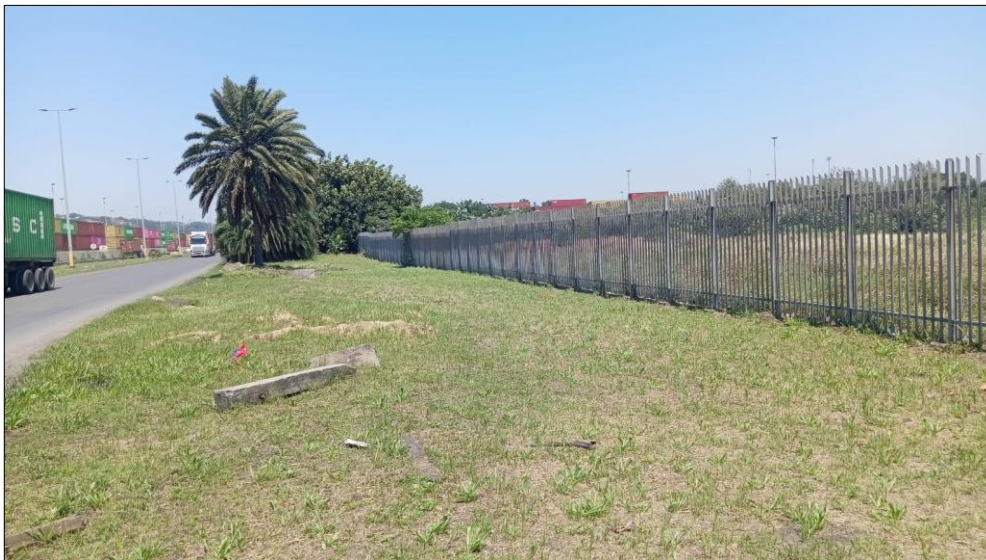
**Figure 22. Photo 05:** Shortly cropped lawn with *Phoenix reclinata* visible in the background along Langeberg Road.

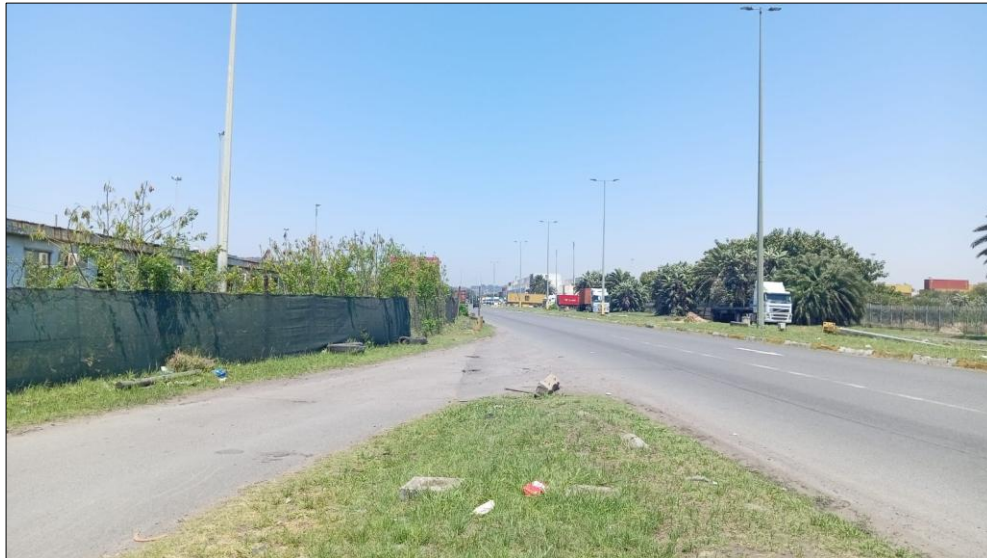
**Figure 23. Photo 06:** Shortly cropped lawn with *Phoenix reclinata* clumps visible in the background along Langeberg Road.

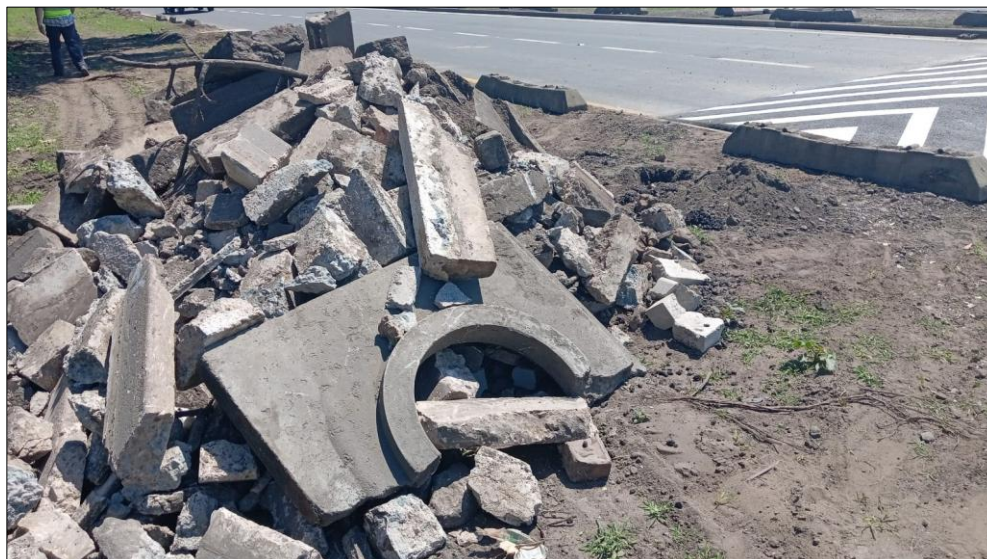
**Figure 24. Photo 07:** Construction rubble located along the road verge on Bayhead Road.

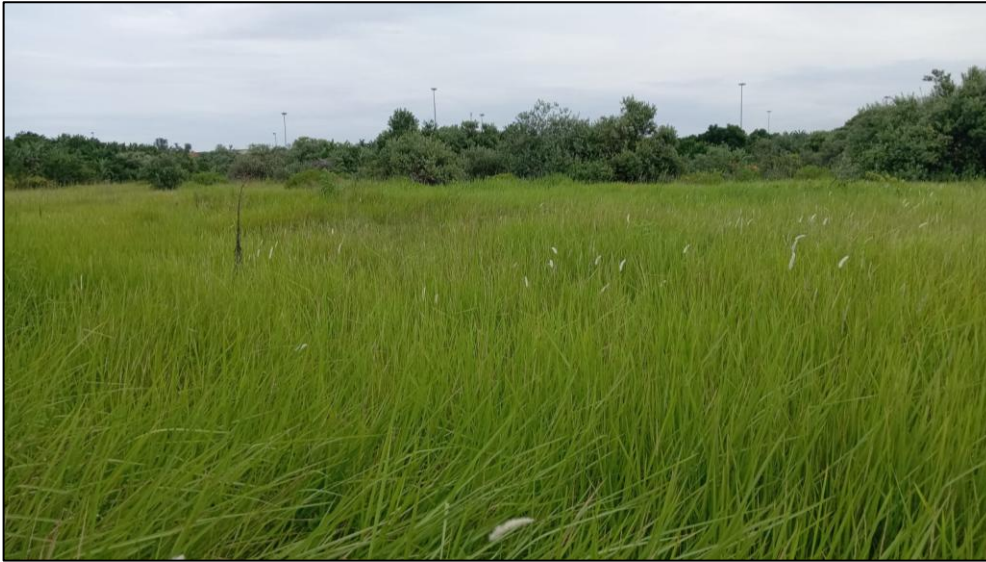
**Figure 25. Photo 08:** View of hygrophilous grassland with scattered tree cover.

vegetation comprised a hygrophilous grassland dominated by *Imperata cylindrica* with *Digitaria eriantha* also prevalent in some areas. Scattered tree cover along the fenceline but within the reserve included clumps of *Brachylaena discolor*, mixed with *Stelitzia nicolai*, *Phoenix reclinata* and *Clerodendrum glabrum*.

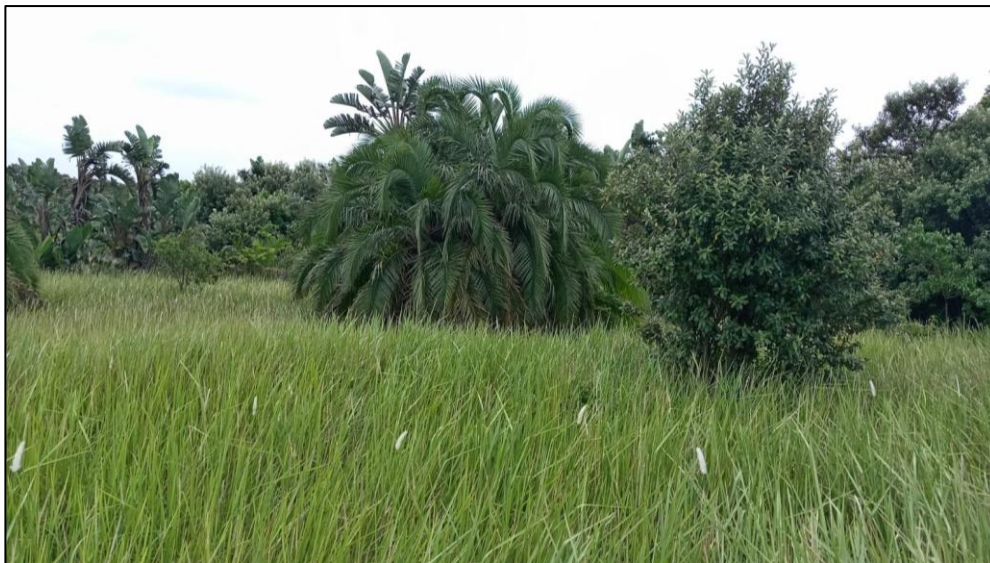
**Figure 26. Photo 09:** View of hygrophilous grassland with scattered tree cover.

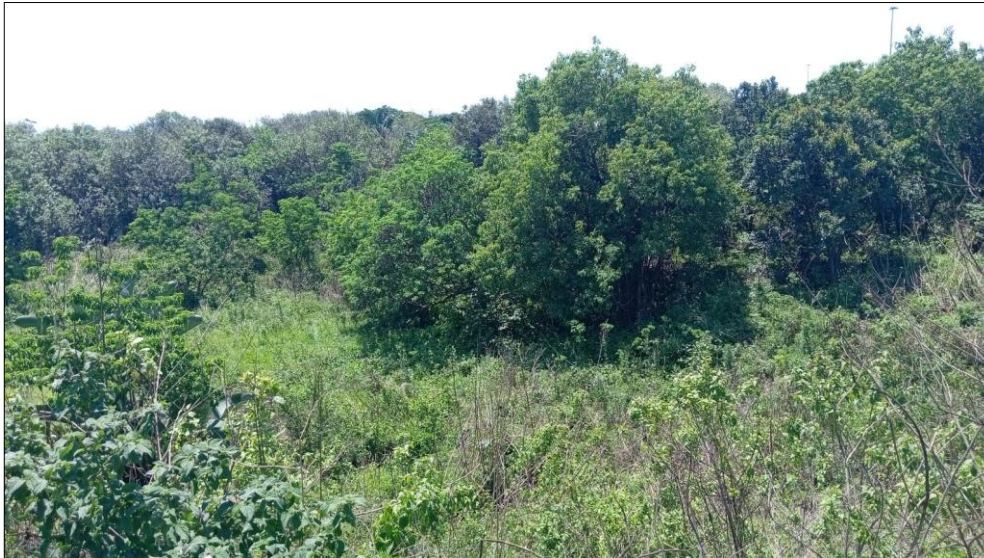
Figure 27. Photo 10: View of Community 4 from road above.

A small patch on the south-easternmost end of Bayhead Road adjoining the Amanzimyana Stream (which has been canalised), appeared to exhibit a higher cover and diversity of indigenous species with alien invasives also represented but not as extensively as in Community 1. Indigenous species represented within this patch of woodland/shrubland included moderate cover of *Trema orientalis*, moderate cover of *Clerodendrum glabrum*, high cover of *Brachylaena discolor* and *Strelitzia nicolai* low cover of *Apodytes dimidiata* and *Searsia chirindensis*. This was interspersed with invasive shrubs such as *Chromolaena odorata*, *Ricinus communis* and *Lantana camara*, *Poinsettia (Euphorbia heterophylla)*, *Tagetes minuta*, with the understorey characterised by a mixture of *Asystasia gangetica*, *Senecio tamoides*, *Rivina humilis* low cover of *Smilax anceps* intertwined amongst other vegetation and low cover of *Morus alba* and *Tecoma stans*. Along the canal vegetation comprised a mixture of *Strelitzia nicolai*, *Brachylaena discolor* and *Chrysanthemoides monilifera* mixed with *Tecom stans*, *Lantana camara* and *Chromolaena odorata* primarily.

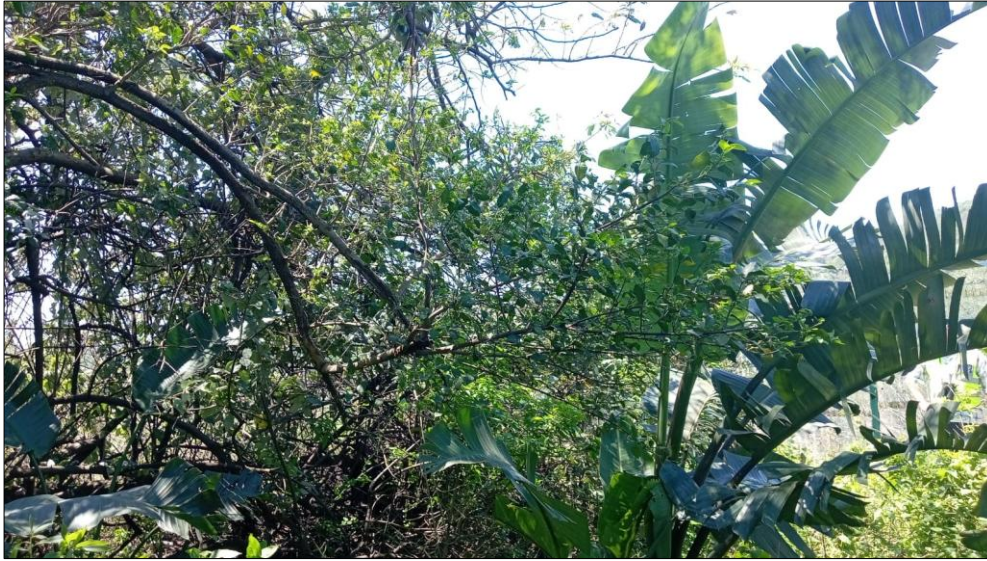
**Figure 28. Photo 11:** View of Community 4.
