APPENDIX C4 – VEGETATION REPORT

Vegetation Report

***Application for rectification in terms of Section 24G –
Farm Blaauwater No. 65 in the Dr Beyers Naudé Municipality in
the Eastern Cape***

October 2019

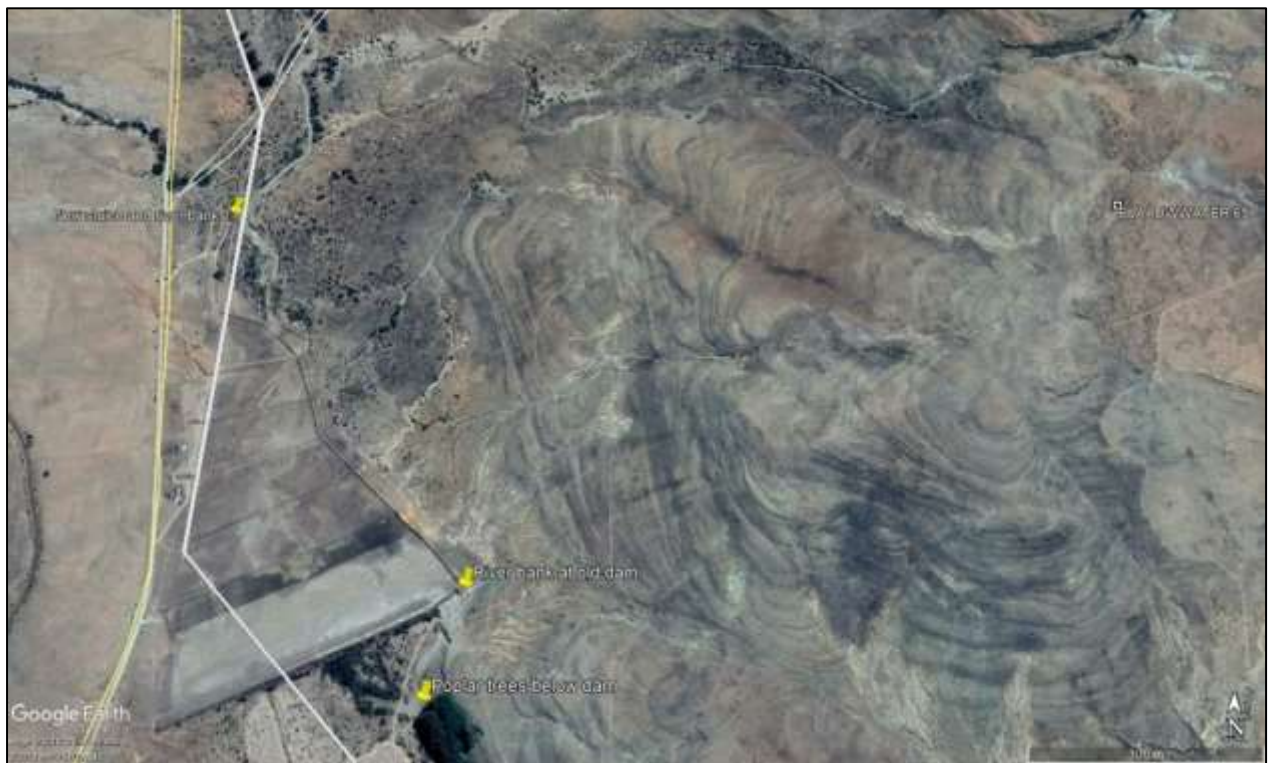
Figure 1. Google Earth aerial image showing the location of the newly-constructed sluice gate, 'upstream' to the north-west, diverting floodwaters to the old dam. An old sluice gate and irrigation channel are located amid Poplar trees to the south-east, 'downstream' of the spillway of the old dam (which also feeds a series of flood-irrigation basins planted up with lucerne).
